COLLISION
ENGINEERING ASSOCIATES, INC.

Re: Raley v. Hyundai Motor Company
Your File No.: 51425
C.B.A. Case: 3708

PRELIMINARY

CRASH RECONSTRUCTION REPORT

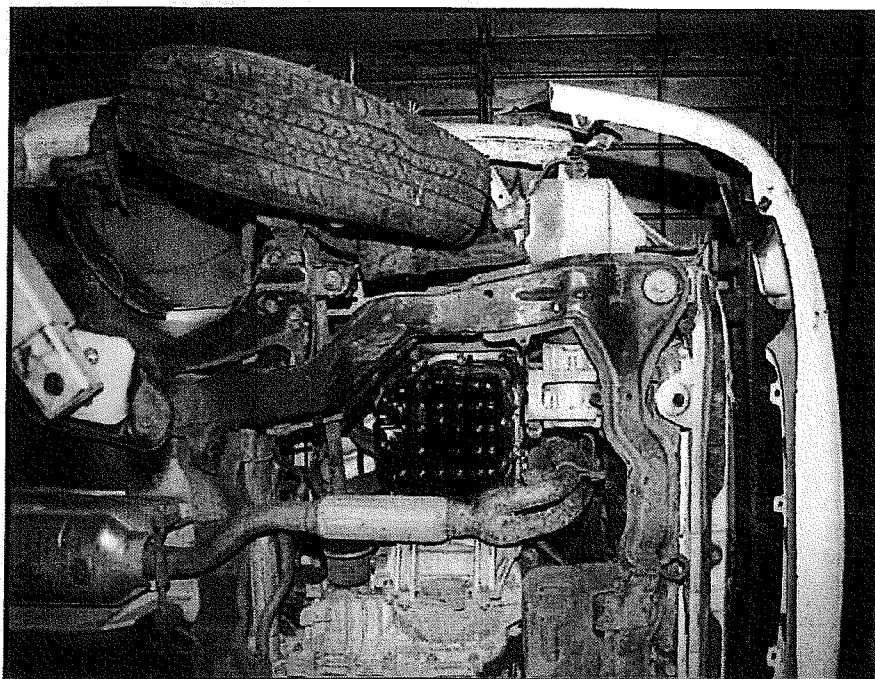
Figure 1. Underside of right front of the Raley vehicle.

Two families of marks were visible on the underside of the sub-frame. The longitudinally aligned set (horizontal in the photographs) was comprised of deep scratches that penetrated the paint and disturbed the surface of the metal. These marks were not made by contact with a soft surface such as the road shoulder.

The second family of marks was faint and oriented more laterally to the vehicle. In the figures the marks are about 60 degrees counterclockwise from horizontal. In most areas the marks did not penetrate the paint.

The nature of the second set of marks was consistent with contact with the grass surface of the shoulder where the Raley vehicle rolled over. The orientation of the marks indicated that the vehicle was in a passenger side leading yaw when the marks were made. This was consistent with the orientation of the Raley vehicle at the termination of the first revolution of the rollover.

The second set of marks probably resulted from an undercarriage to ground impact as the Raley vehicle was finishing the first revolution of its two revolution rollover.

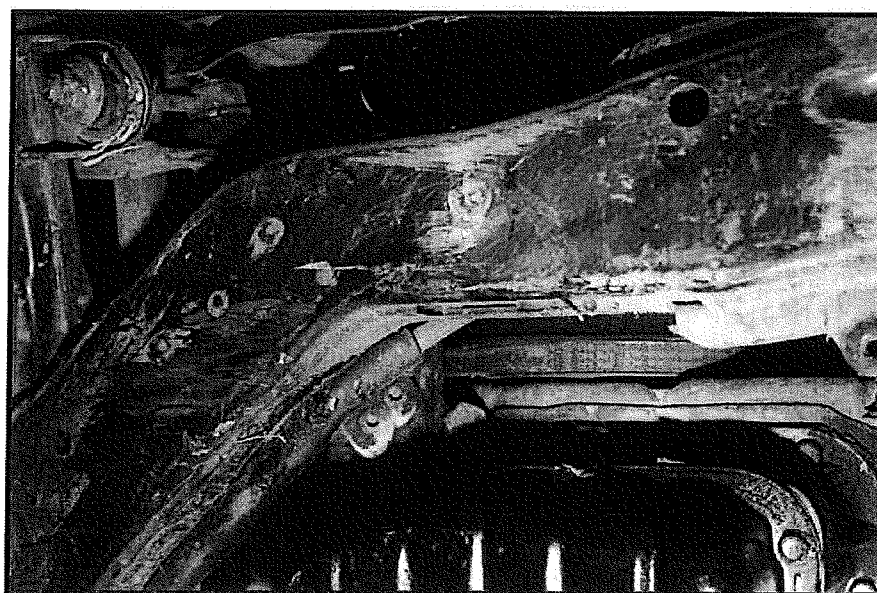
Figure 2. Underside of sub-frame.

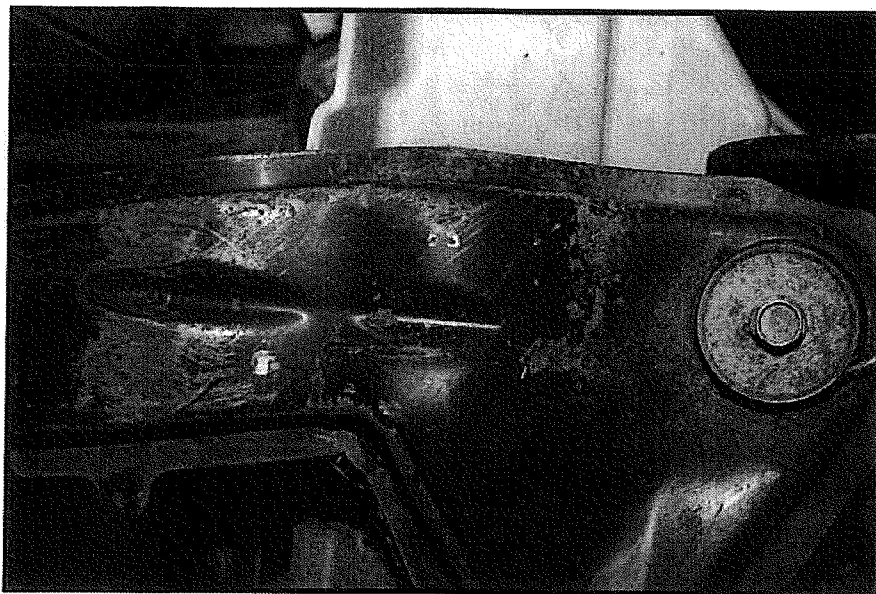
Figure 3. Underside of sub-frame forward of Figure 2.

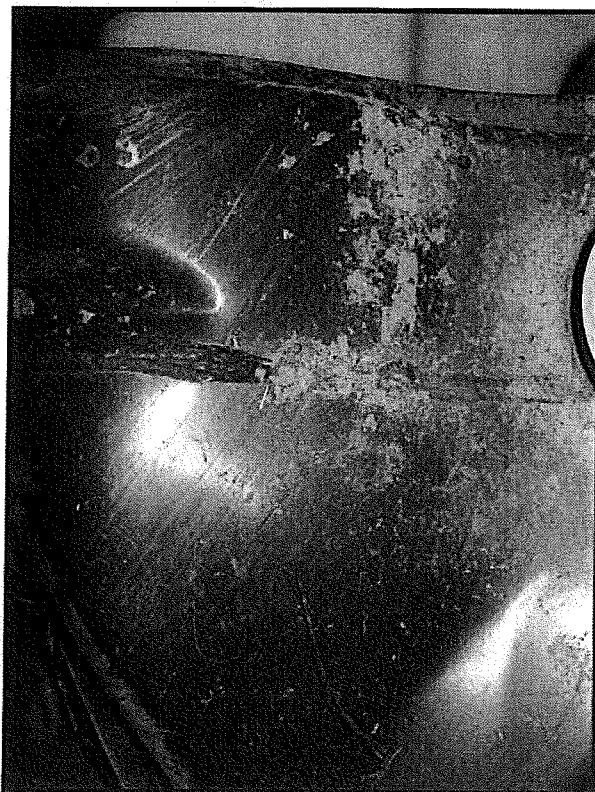
Figure 4. Close-up of central region of Figure 3.

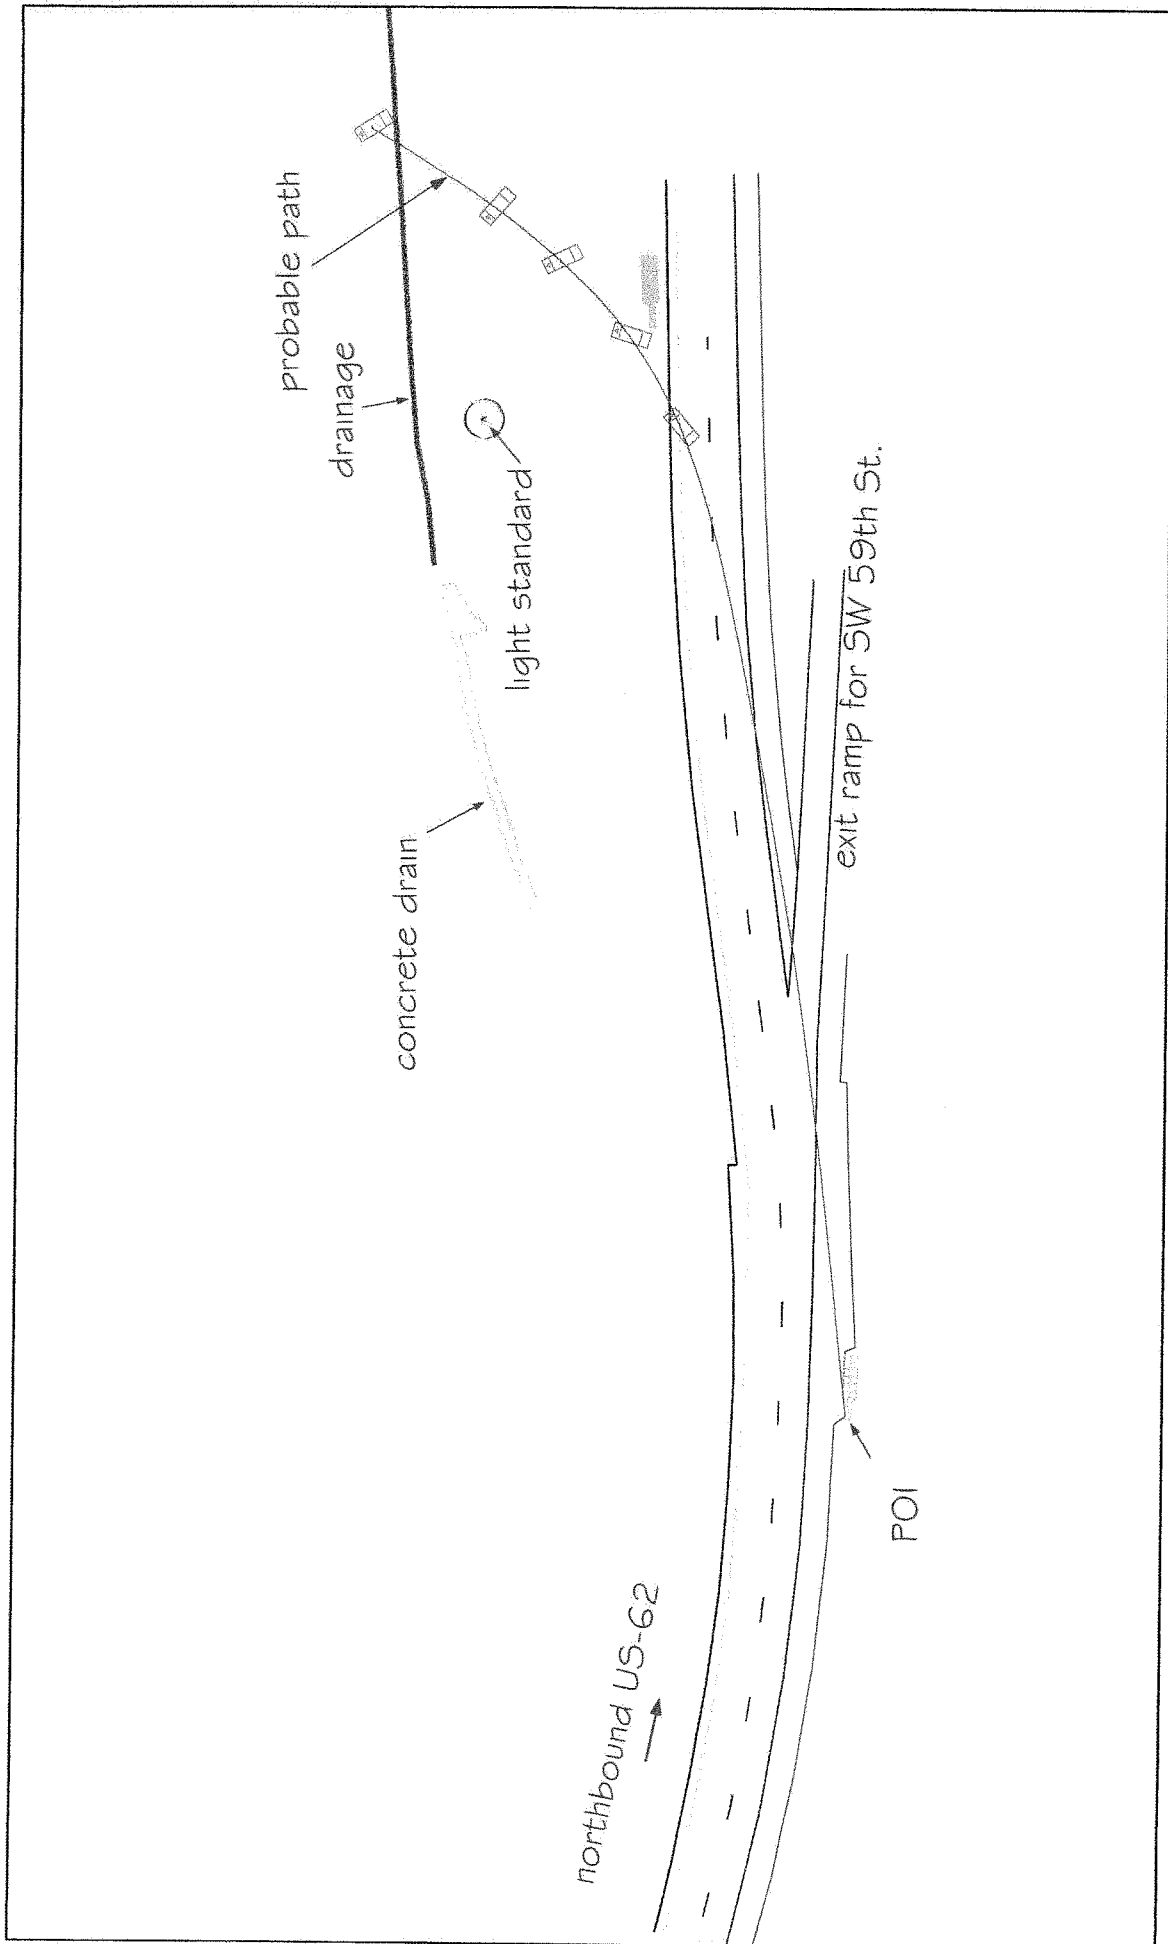
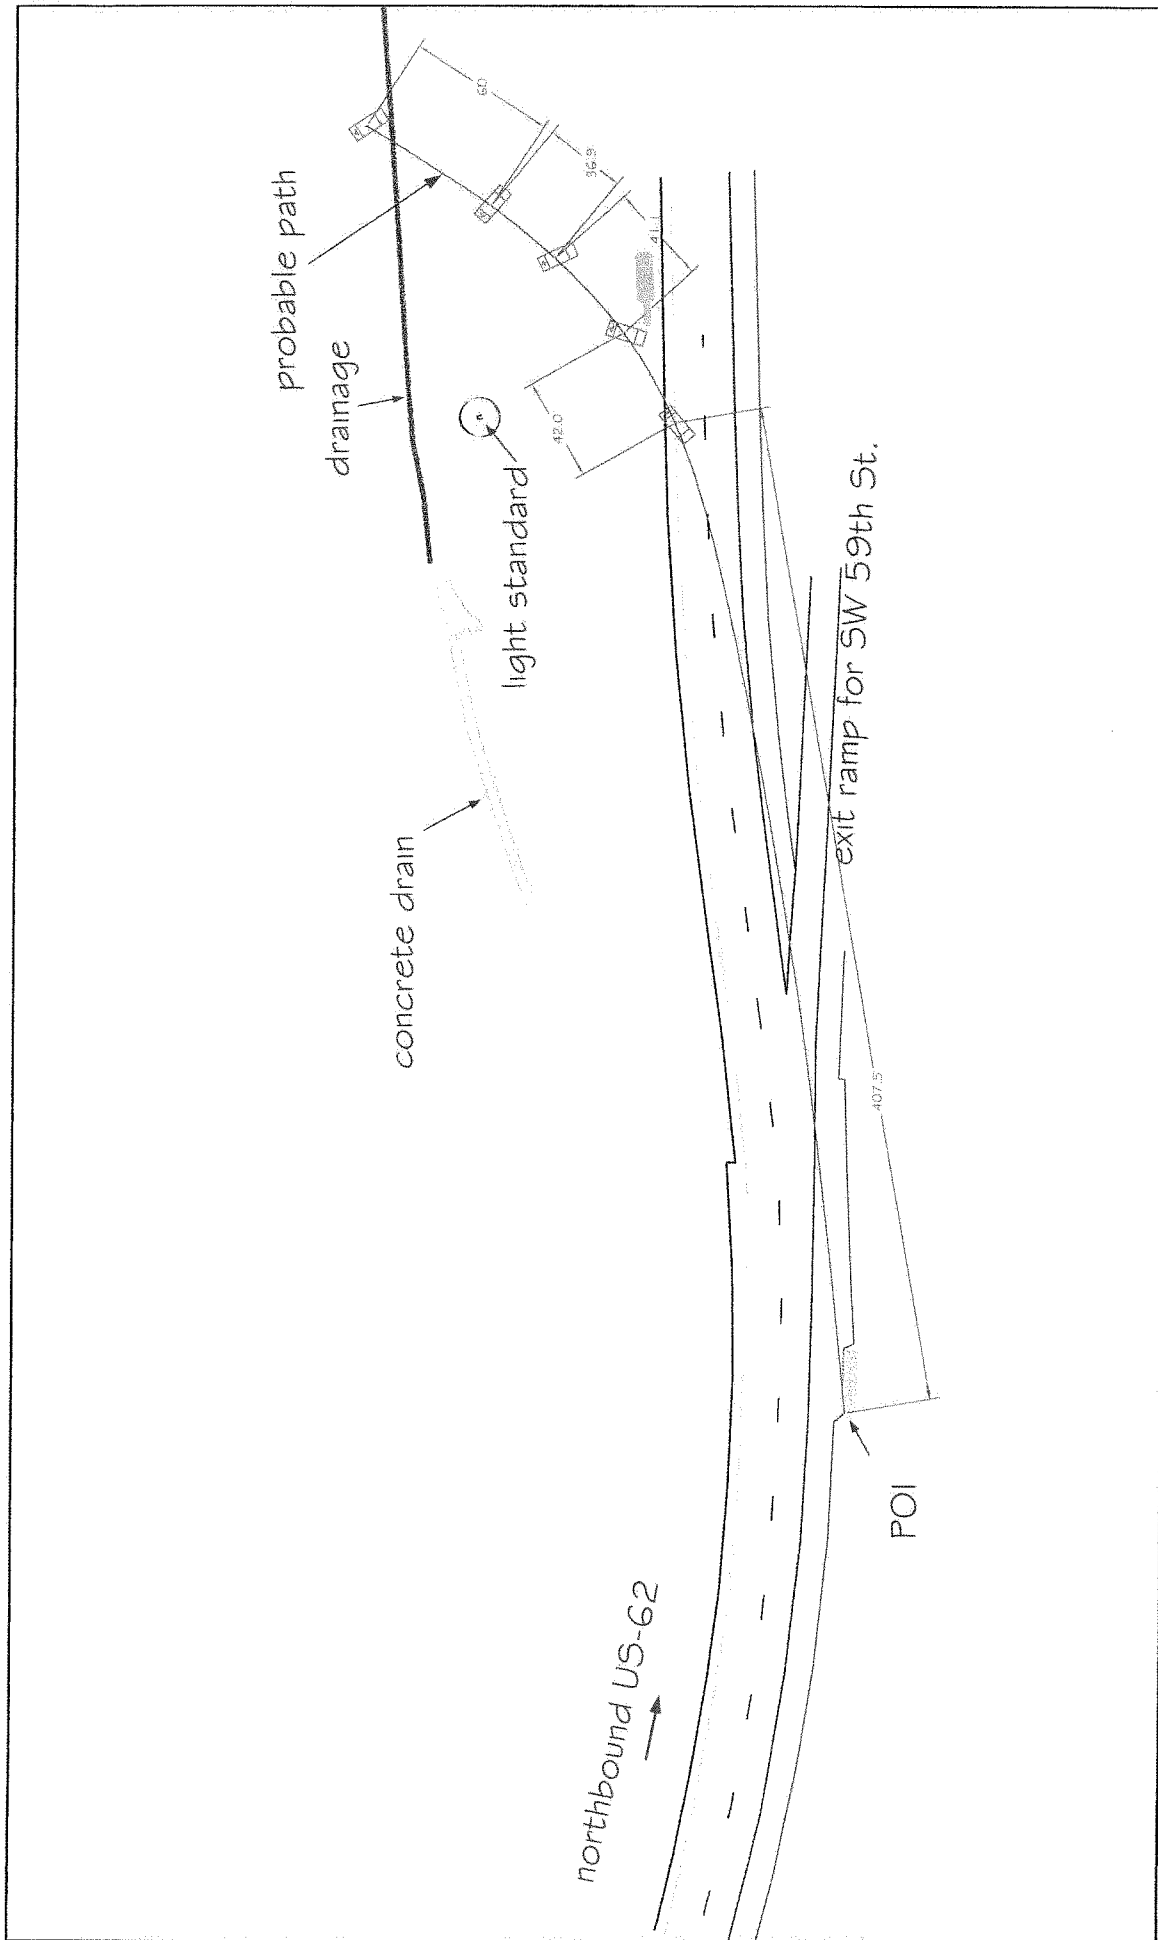
At the time that I made my modifications based on the photogrammetric study, I noticed an error in my original crash reconstruction. The probable path of travel of the Raley vehicle as presented in my original reconstruction would have resulted in the Raley vehicle striking the highway barrels on the left side of the northbound lanes. This was corrected in the modifications that were presented in my second deposition.

Attached is a revised scale drawing illustrating my opinions concerning the path traveled by the Raley vehicle. In it the probable path that the Raley vehicle followed has been modified such that the vehicle avoids the left side highway barrels. My opinions concerning the rollover are my original opinions as presented in my December 5, 2006 deposition.
